Adelphi Pool Survey

**Prepared by Dave Almy, Almy Architects
&
Mark Wilkinson, Paddock Swimming Pool Company**

August 2020

Adelphi Swimming Pool Survey

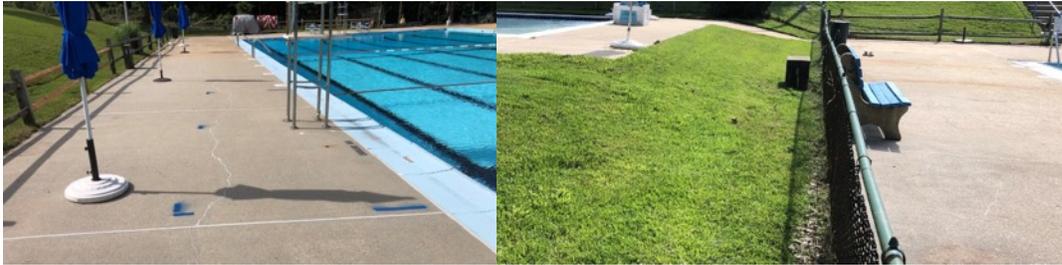
The pool decks as a whole are in reasonable condition and have considerable life ahead. It appears the 50 M Main Pool decks on the East and North sides of the pool slope towards the pool by design. The configuration introduces deck runoff into the concrete gutter system on the East side of the 50 M pool. Allowing deck water to enter the swimming pool recirculation system is not allowed in current code regulations. The possibility of foreign materials (including fertilizer from the grassy areas to the East) can adversely affect water chemistry and introduce unwanted phosphates into the pool water along with other unwanted organic substances.

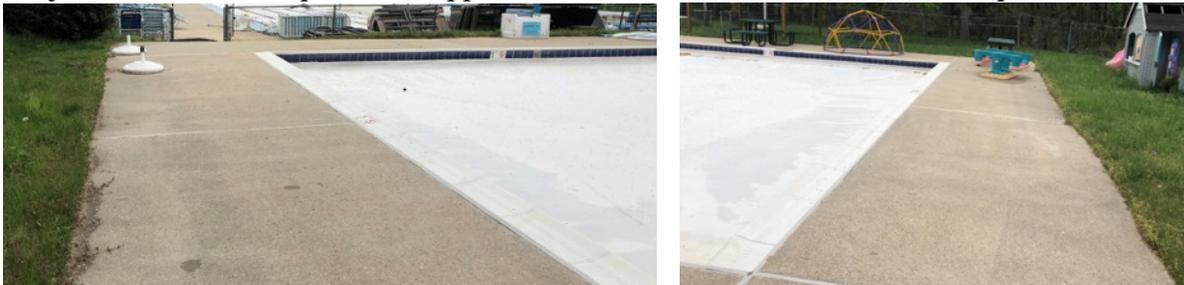
As mentioned above in the site description, the wading pool has a steep ramp connecting the wading pool deck to the main pool deck. This ramp is considerably steeper than the current pool code or ADA Guidelines allow.

The 24" vertical drop between the two decks equals a slope of over 2" per foot, over 200% steeper than current code for a handicap ramp (assuming it had handicap rails) and 400% steeper than the allowed pool deck slopes.

The Wading Pool decks slope away properly but the ramp up to the wading pool does not meet code and could be considered a safety hazard. If as stated above, if a major renovation were to be considered, the ramp could be replaced with a set of stairs and a Code compliant ramp could be constructed between the Main pool deck and the wading pool deck.

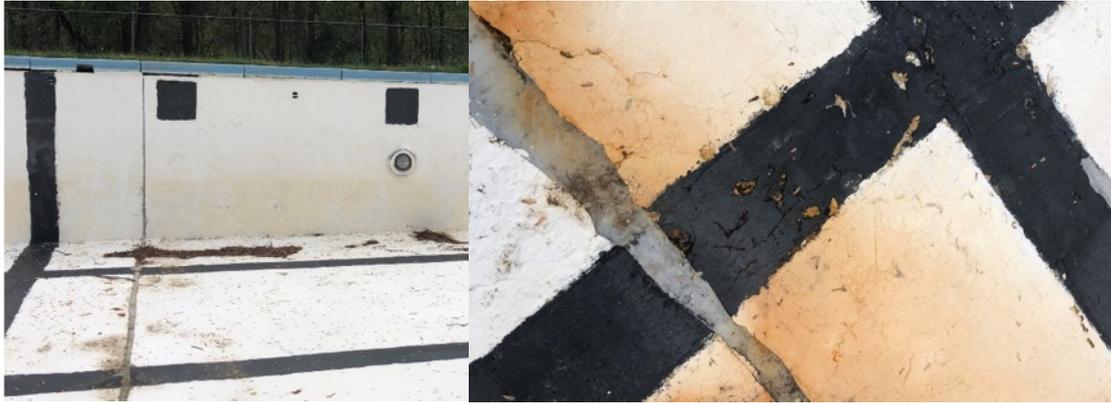
The concrete adjacent to the expansion joint sealant is showing signs of deterioration and the floor joint closest to the deep end have a rust colored stain from either the reinforcing in the joint corroding or the metal piping in the pool corroding and staining the pool surface. It is most likely metallic pipe corrosion. There is visual evidence of concrete spalling and minor structural cracks, most of which have had some level of repair effort. The multiple layers of pool paint could be covering areas of advanced deterioration.

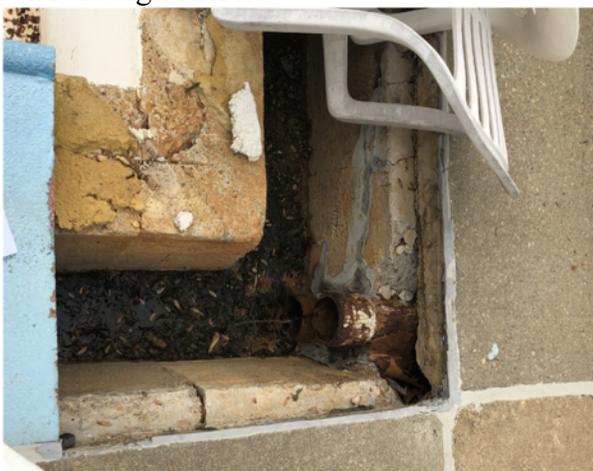
The walls appeared to still be relatively plumb, and free from major deterioration. Inspection of the top of the pool walls did indicate some advance deterioration in the concrete gutter trough. An inspection of this portion of the pool wall was available at the Northeast corner of the pool where the coping stones were removed. The rear pool wall was cracked and out of plane with surrounding concrete.

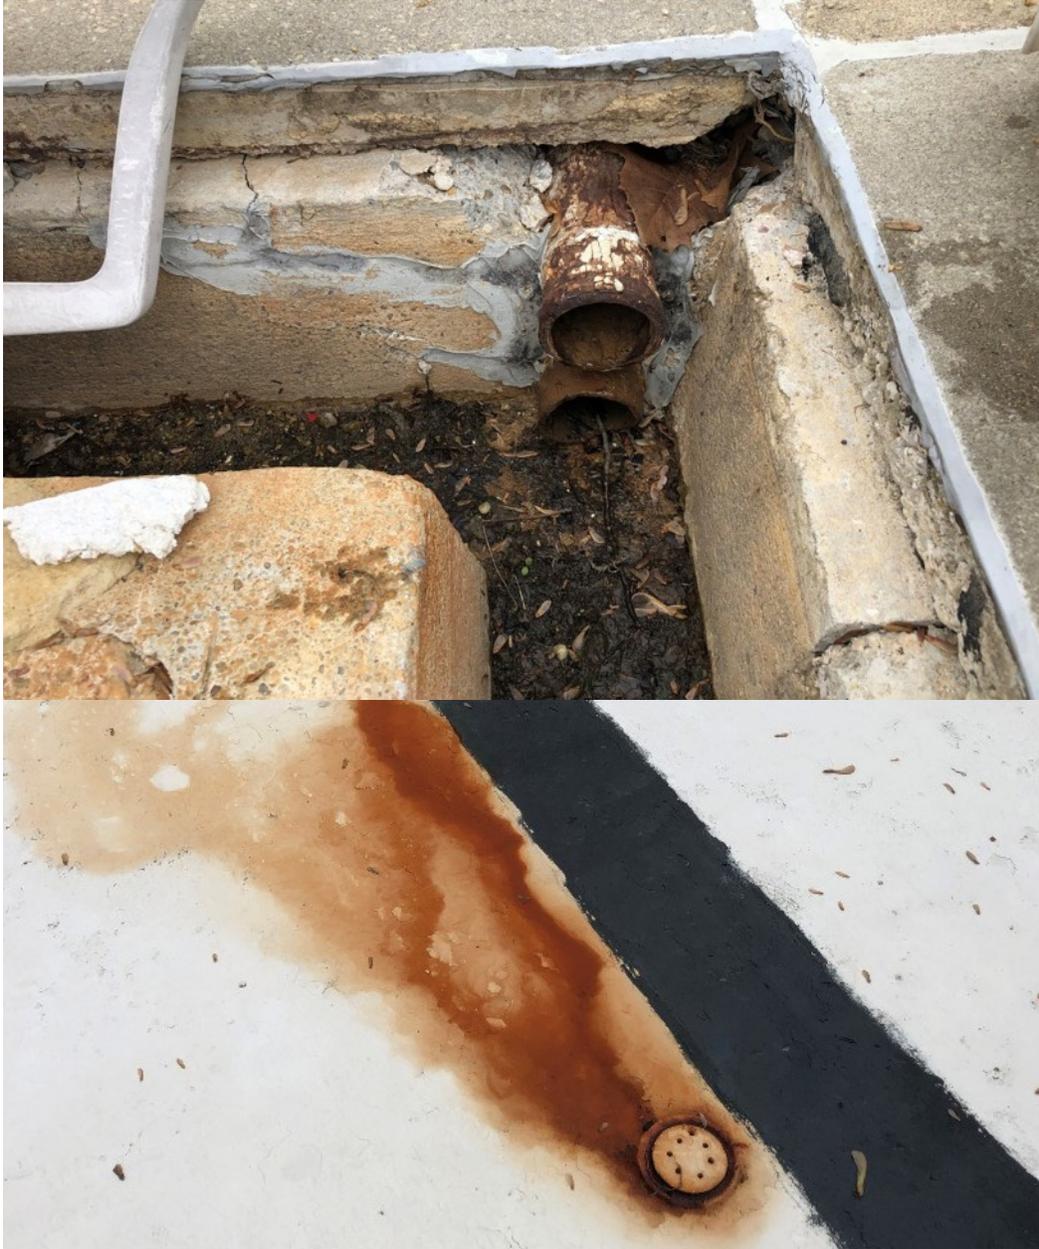
The coping stones appear to be loose, staying in place mainly by the weight of the stone. The pipes coming from the wading pool are ferrous metal and are severely deteriorated, to a point of expanding and cracking the concrete gutter wall.

It is likely the main pool structure is leaking quite a bit from fractures in the concrete perimeter gutter system and possibly from the buried corroded ferrous metal piping system.

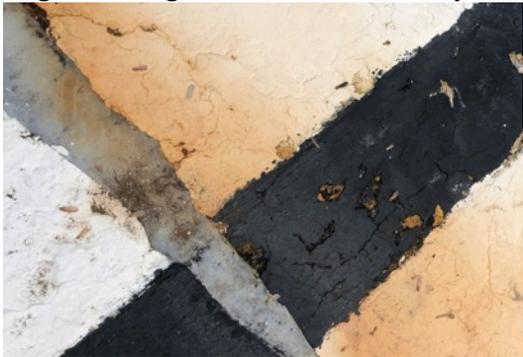
The 50M pool has a painted finish that appears to have multiple coats. The surface has not been properly prepared before each new layer being applied and now presents somewhat of a rough finish. The paint is spalling, is being stained by the corroding metal pipe systems, and has long since lost the crisp straight lines of a new paint application. It is likely paint chips dislodge and migrate through the water on the way to the filter system.

The main pool currently has multiple coats of pool paint on it. If the club were to decide to continue on with the existing structure after repairing the piping system and attempting to fix the concrete gutter, it would be wise to have the pool surface sand blasted, cracks and spalling areas repaired, gutter repaired (if possible), seal the gutter trough and either plaster the pool or have it professionally painted. Painting would be the least expensive, but offer the shortest life. New plaster would require new water line tile, new tile racing lanes, tiled expansion joints with sealant, and new plaster. We would not recommend that type of investment without replacing the pool structure first.

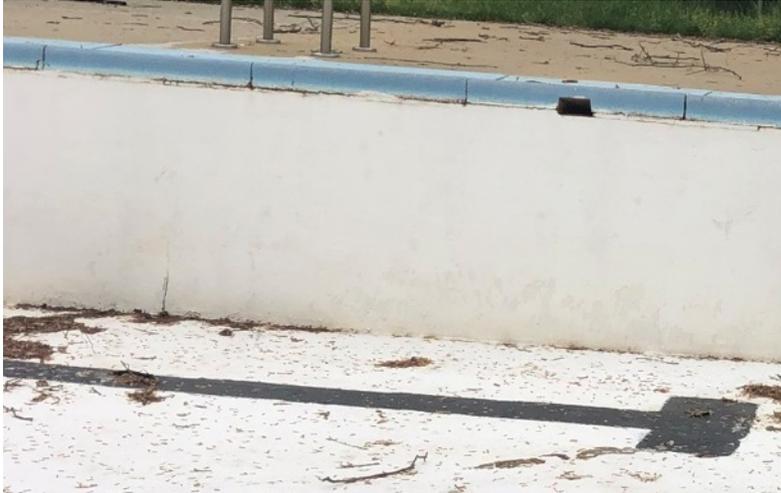
The pool gutter coping stones have been painted as well and some of the stones have broken over time and have not been replaced by identical stones which are visually apparent when viewing the pool. Most of the gutter stones are no longer firmly grouted to the pool wall, illustrated by a horizontal crack where the bottom of the stone comes in contact with the top of the pool wall.

If the club elects to continue with the pool as it is for the foreseeable future, it would be wise to have a coping stone manufacturer make molds of the existing coping stone and produce some new ones to take the place of the damaged stones.

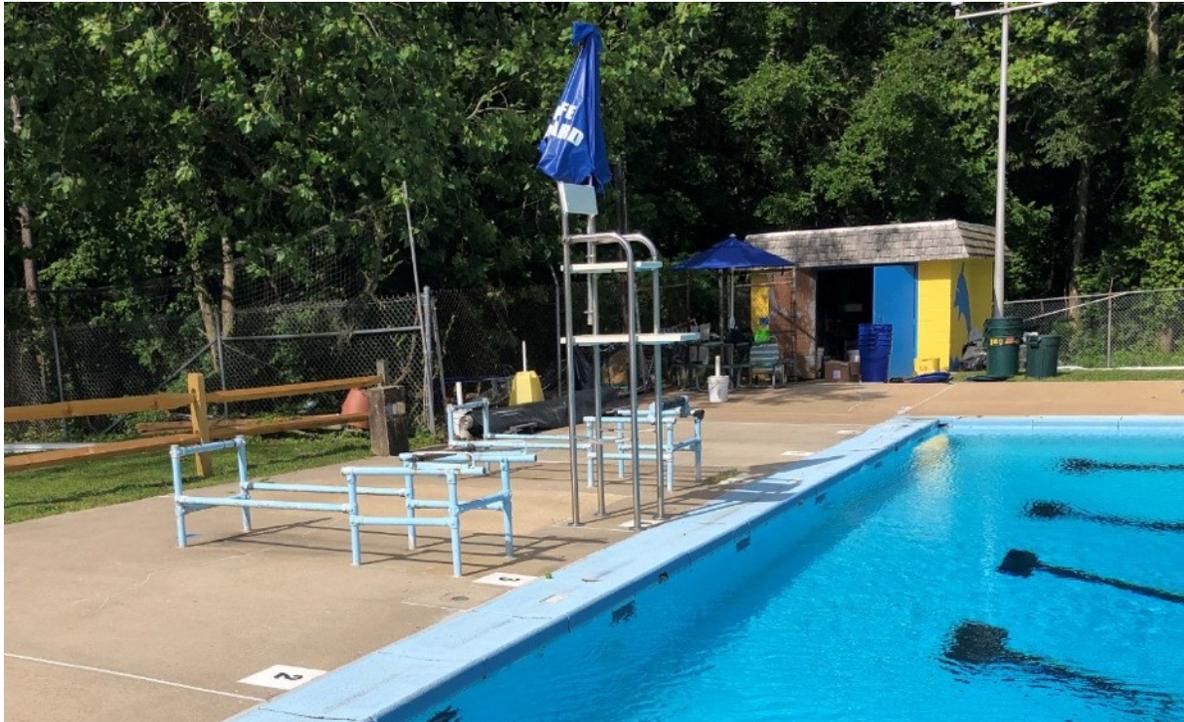
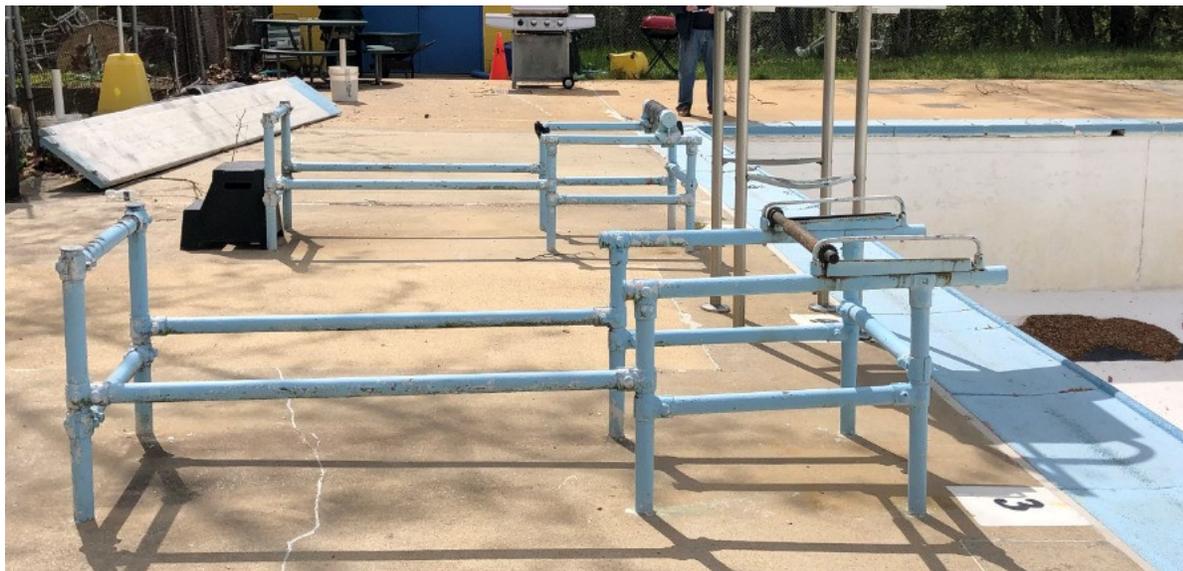
Two (2) one meter diving stands of constructed of painted pipe, one with a fixed fulcrum and one with a broken fulcrum. Two (2) Durafirm 16' diving boards were on site and one of the boards was installed at the last site visit. The diving stands do not have access ladders or hand rails,

although a plastic step stool was positioned behind one of the stands. The geometry of the underwater envelop does not meet the minimum dimensions for this diving stand and diving board combination. It is the manufacturer's requirement that any pool using their diving boards meet the minimum requirements for US Diving, which this pool does not meet.

The pool has a custom metal waterslide with a low sided stainless steel flume, a painted pipe rail tower, and what appears to be a newer stairway of stainless steel. The slide supports in the swimming pool are between a racing lane along the wall and the 2nd lane from the wall. This waterslide configuration can exist due to being “grandfathered” but could not be duplicated today

11. New deck drains
12. Removal or replacement of existing waterslide
13. Removal of the existing diving equipment or reconfiguring the diving well to meet current code

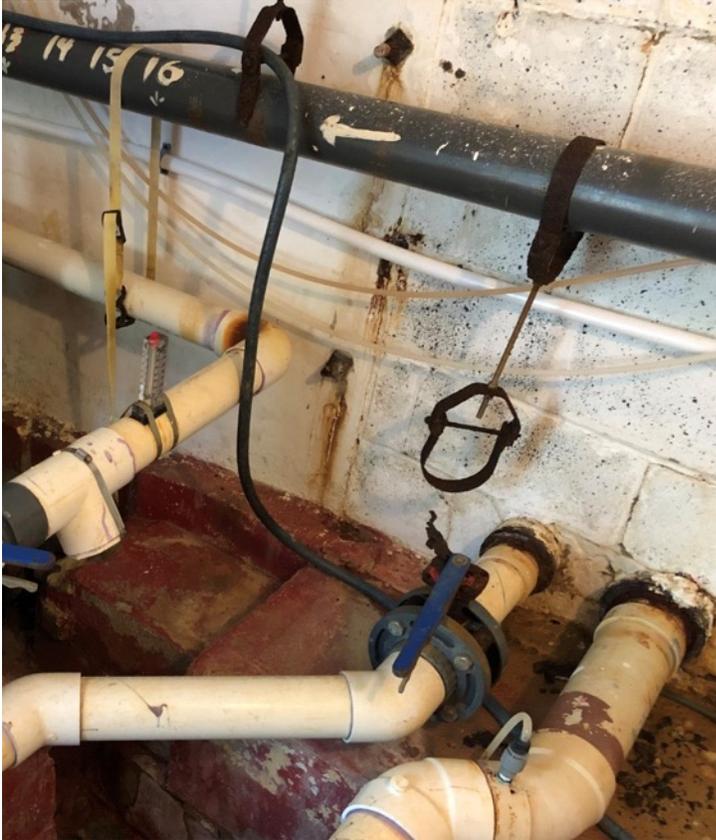
The pool piping system is a combination of schedule 40 PVC and existing cast iron, ductile iron; black steel or galvanized pipe, and possibly some terracotta piping in the filter cells/beds. The valves are a combination of modern PVC bodied valves, cast iron, valves, and modified valve bodies with custom plates bolted over the abandoned partial bodies. There are multitude of pipe repairs, patches and other efforts to keep the system in operation.

The piping is poorly supported and the supports that do exist are severely corroded.

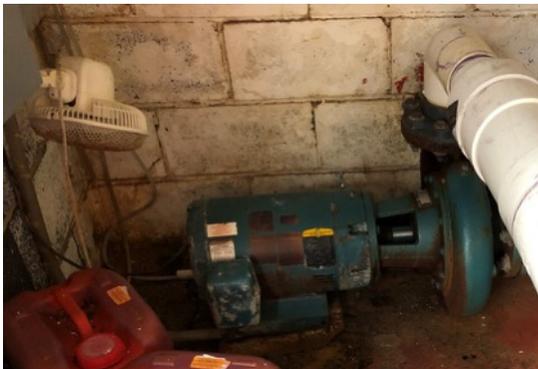
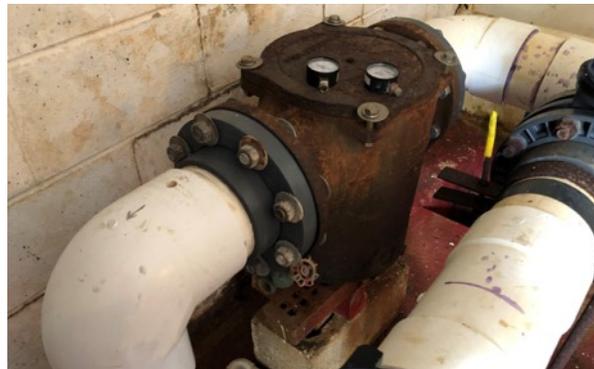
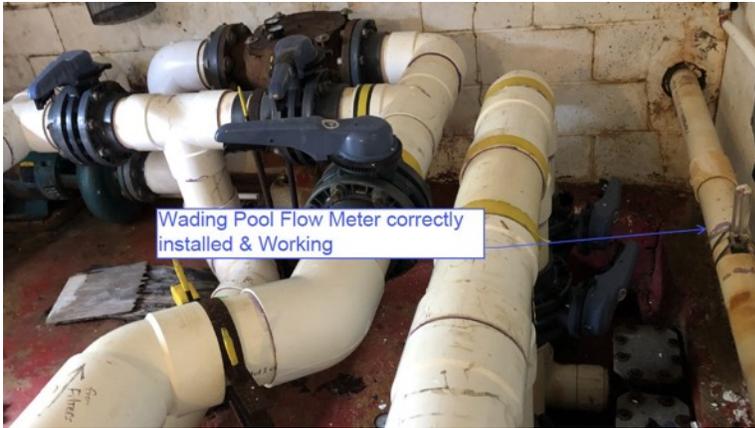
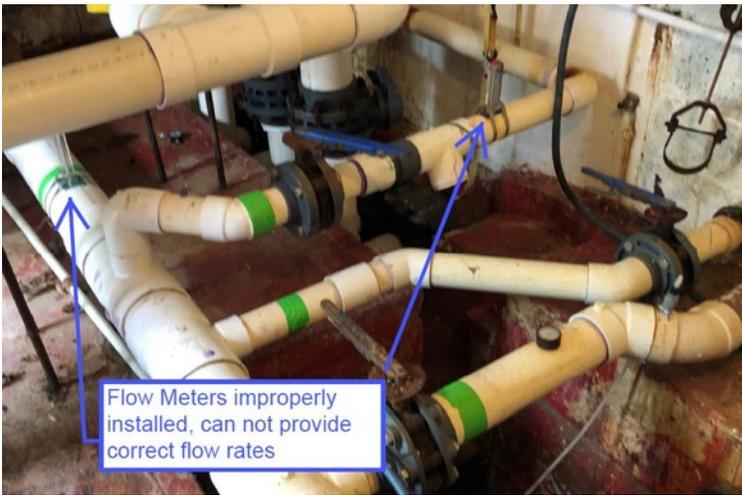
The system instruments such as flow meters and gauges are either not functioning or installed so they cannot function properly.

The pump motor is not properly mounted, does not have the correct concentric reducers, and it appears to be overheating due to the fan mounted over the motor. The hair and lint strainer is cast iron, corroded and need tools to change the strainer basket.

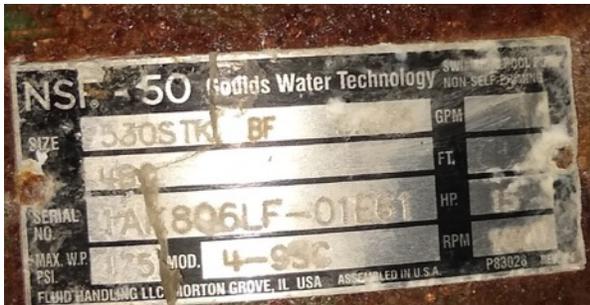
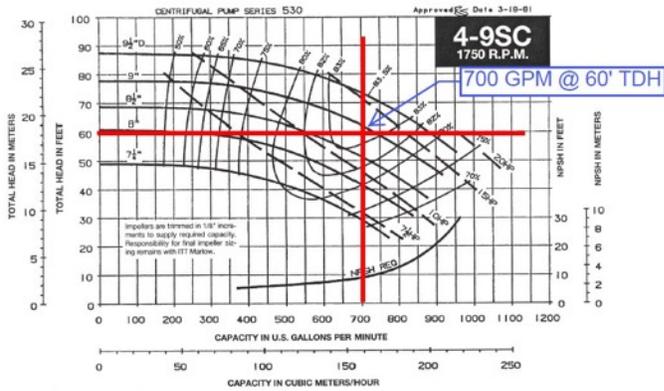
Due to the lack of operational flow meters it was not possible to determine if the pump was operating at the correct flow rate. The Marlow 4-9SC 530, 15 HP pump is a replacement from the original and unfortunately, the pump name plate did not state the impeller diameter. Based on some assumptions, it's likely the pump is producing approximately 700 GPM which would meet the minimum code flow rate per our volume calculations.

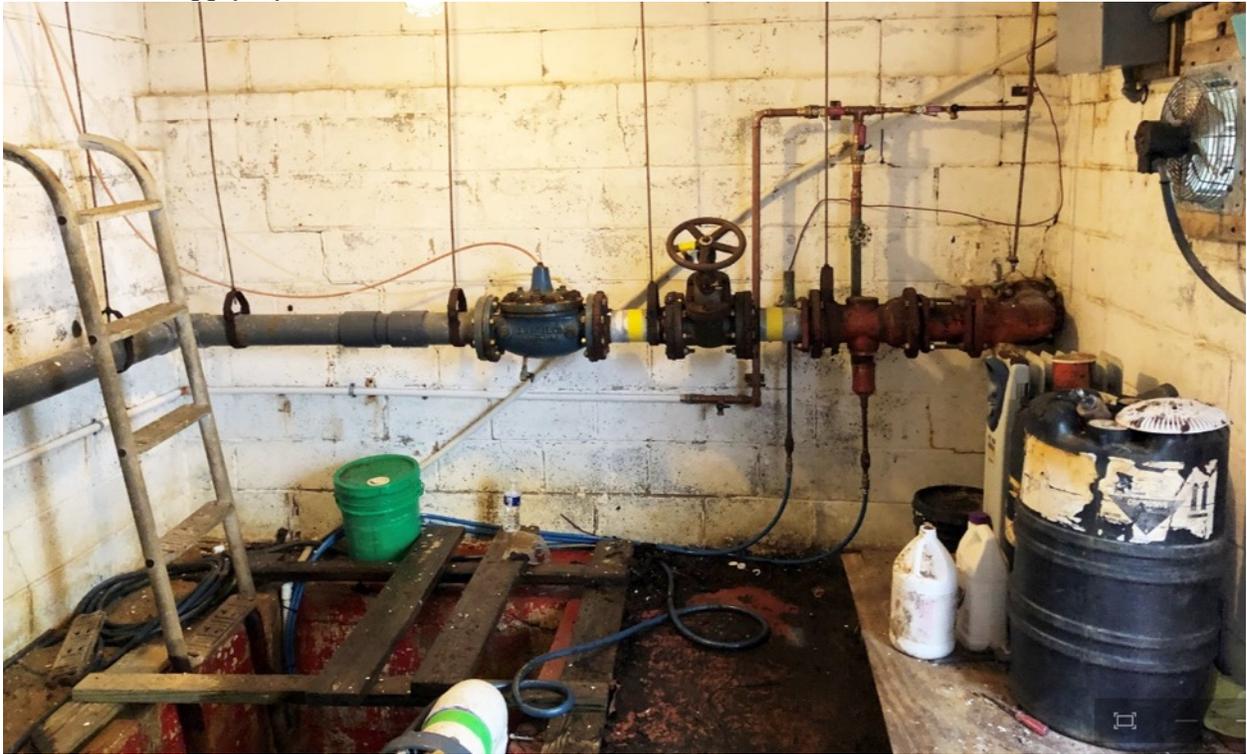
The pool filter room has an incoming 4" water line and does not have a code required back flow preventer. The fill and make-up water is introduced by a Cla-Valve float operated make-up system that adds water when the water in the filter cell/bed drops below a preset level. The system lacks the code required air gap. The mechanism is accessed thru an unsecured aluminum hatch that is located on the pool deck

5. Provide a code compliant fresh water system with a back flow preventer
6. Provide code compliant underwater and deck surface lighting (if pool used at night)

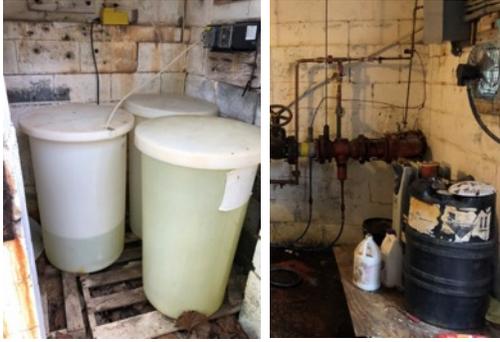
A separate liquid chlorine room is adjacent to the main filter room and houses the liquid chlorine vats and pumps. The liquid hydrochloric acid is stored in the filter room adjacent to the deep valve pit. Both of these approaches could use some upgrades for operation and safety.

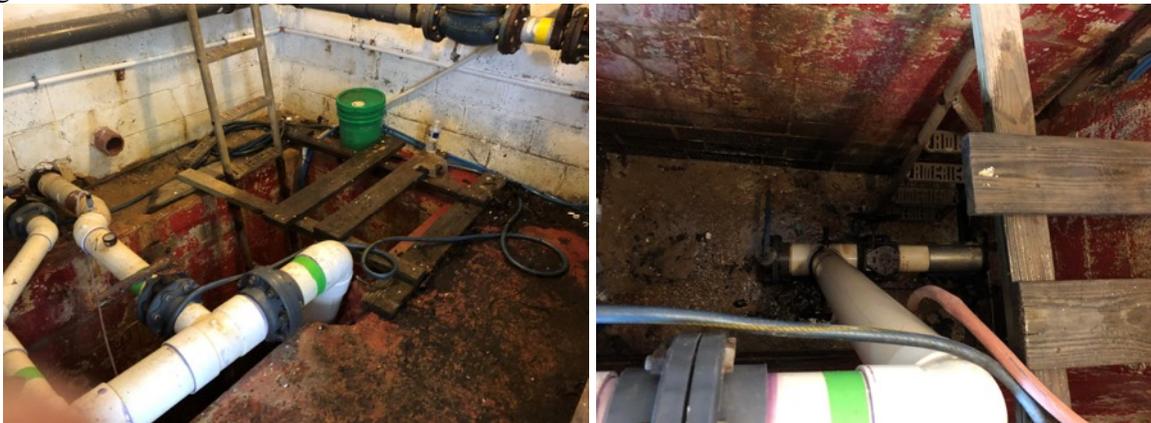
The filter room was designed 65 or 70 years ago when safety was not a major consideration. The room has a very deep pit in the left hand corner without guard rails or a safe access ladder. Currently the surface of the pit is bridged in one corner by a pair of water logged 2x4s and two 2x6 planks. This condition is extremely unsafe and should be corrected with a suitable grate and guard rails.

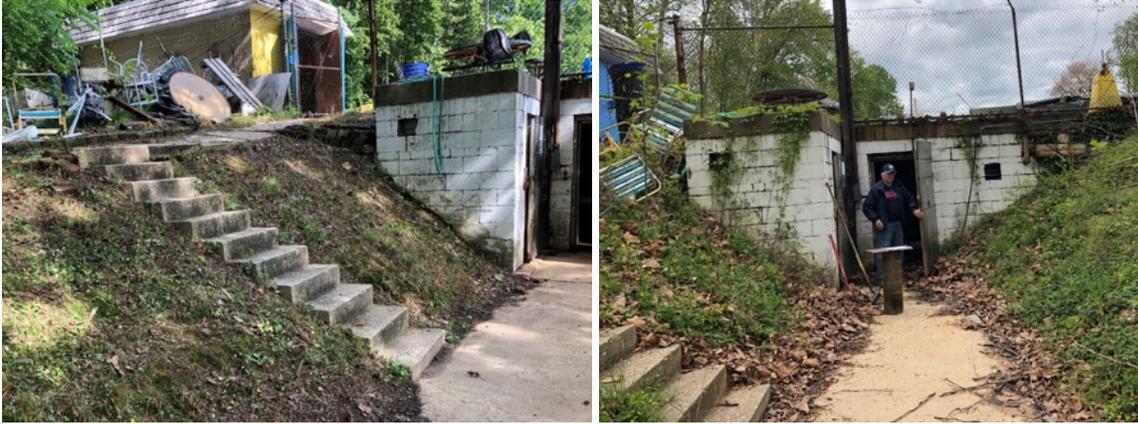
The filter Room building is in poor condition and the scope of this report is not to provide an structural analysis of the building. A visual inspection indicates the CMU walls are compromised, the doors are barely functional, the site drainage appears to flood the room, the ventilation is poor at best. The concrete stairs down to the filter room lacks a handrail.
