Adelphi Pool Survey

**Prepared by Dave Almy, Almy Architects
&
Mark Wilkinson, Paddock Swimming Pool Company**

August 2020

Adelphi Swimming Pool Survey

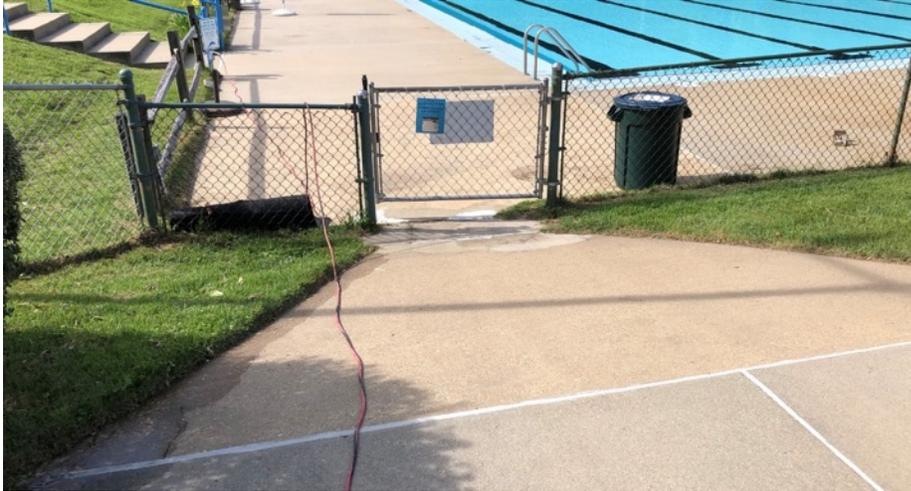
As mentioned above in the site description, the wading pool has a steep ramp connecting the wading pool deck to the main pool deck. This ramp is considerably steeper than the current pool code or ADA Guidelines allow.

The 24" vertical drop between the two decks equals a slope of over 2" per foot, over 200% steeper than current code for a handicap ramp (assuming it had handicap rails) and 400% steeper than the allowed pool deck slopes.

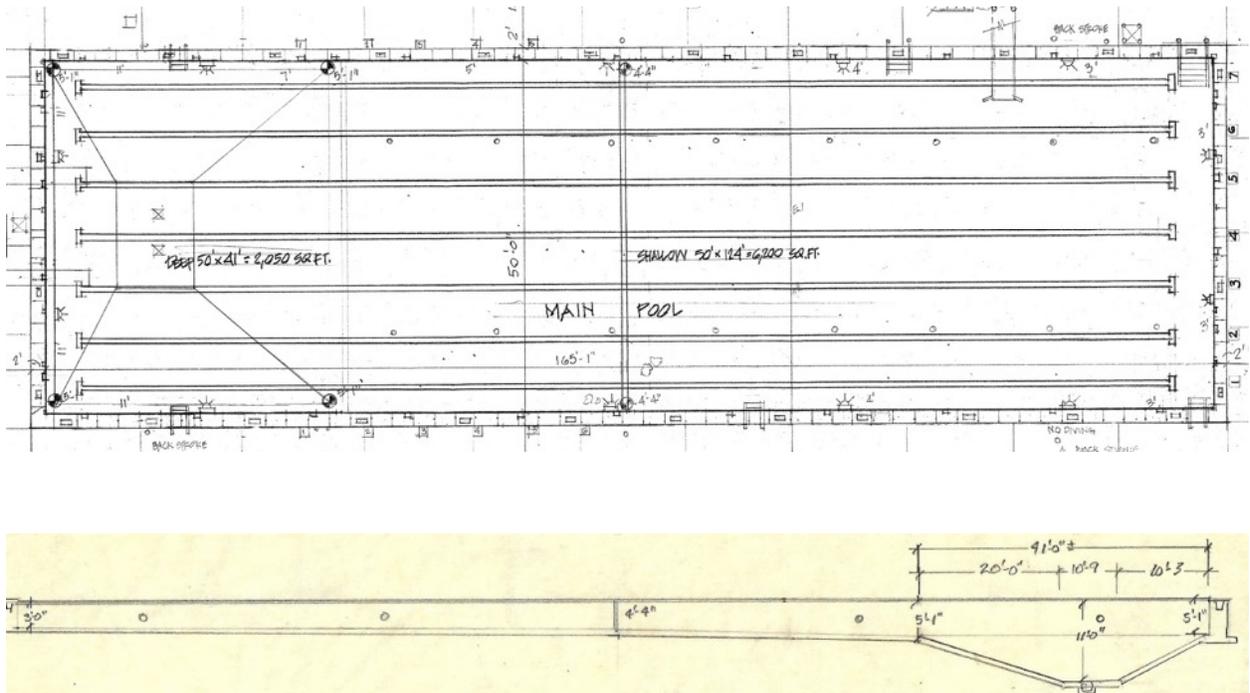
The pool structure is poured concrete and is thought to be approximately 65 to 70 years of age. The pool measures approximately 165' long x 50' wide, with pool depths varying from approximately 3' in the shallow end to 11' in the deep end. Our field measurements are approximate, but based on those measurements, the pool data we developed would be:

The pool structure was in very good condition for an exterior poured concrete structure approximately 65 years or older. The pool floor has two expansion joints across the 50' dimension, with the joint going up the pool wall to the underside of the coping.

The concrete adjacent to the expansion joint sealant is showing signs of deterioration and the floor joint closest to the deep end have a rust colored stain from either the reinforcing in the joint corroding or the metal piping in the pool corroding and staining the pool surface. It is most likely metallic pipe corrosion. There is visual evidence of concrete spalling and minor structural cracks, most of which have had some level of repair effort. The multiple layers of pool paint could be covering areas of advanced deterioration.

The walls appeared to still be relatively plumb, and free from major deterioration. Inspection of the top of the pool walls did indicate some advance deterioration in the concrete gutter trough. An inspection of this portion of the pool wall was available at the Northeast corner of the pool where the coping stones were removed. The rear pool wall was cracked and out of plane with surrounding concrete.

The coping stones appear to be loose, staying in place mainly by the weight of the stone. The pipes coming from the wading pool are ferrous metal and are severely deteriorated, to a point of expanding and cracking the concrete gutter wall.

It is likely the main pool structure is leaking quite a bit from fractures in the concrete perimeter gutter system and possibly from the buried corroded ferrous metal piping system.

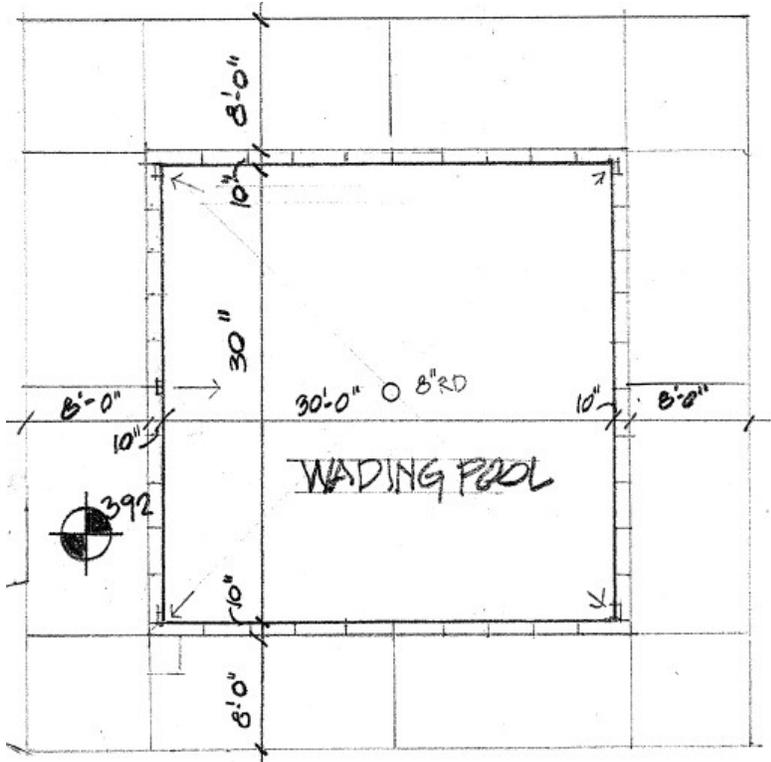
The wading pool structure also appears to be poured concrete and is thought to be approximately the same age as the 50 M pool, 65 to 70 years of age.

The pool structure was in very good condition for an exterior poured concrete structure approximately 65 years or older.

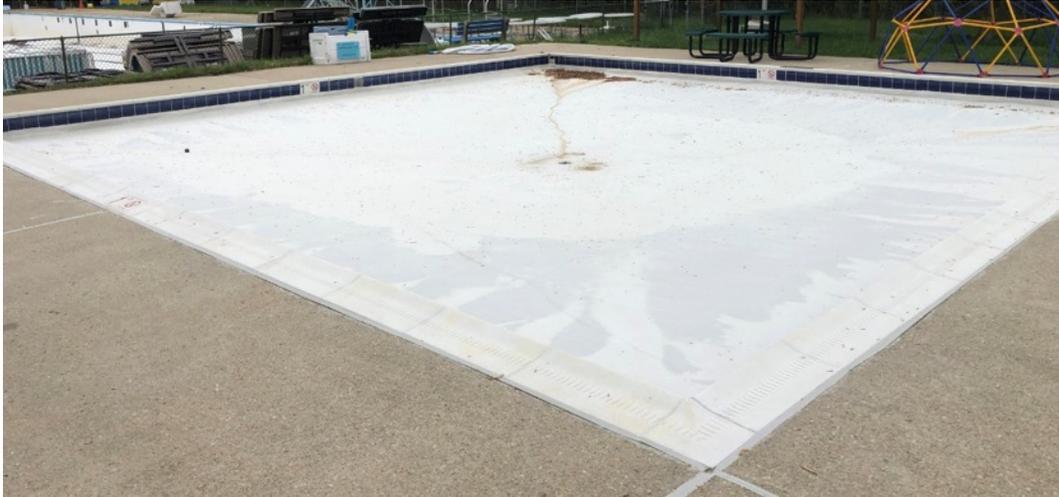
The pool floor appeared to be relatively free from large cracks and the pool walls also appeared to be plumb and true to line. The top of the pool wall has 10” wide single diamond Federal Stone coping and 6” waterline tile, both in very good condition.

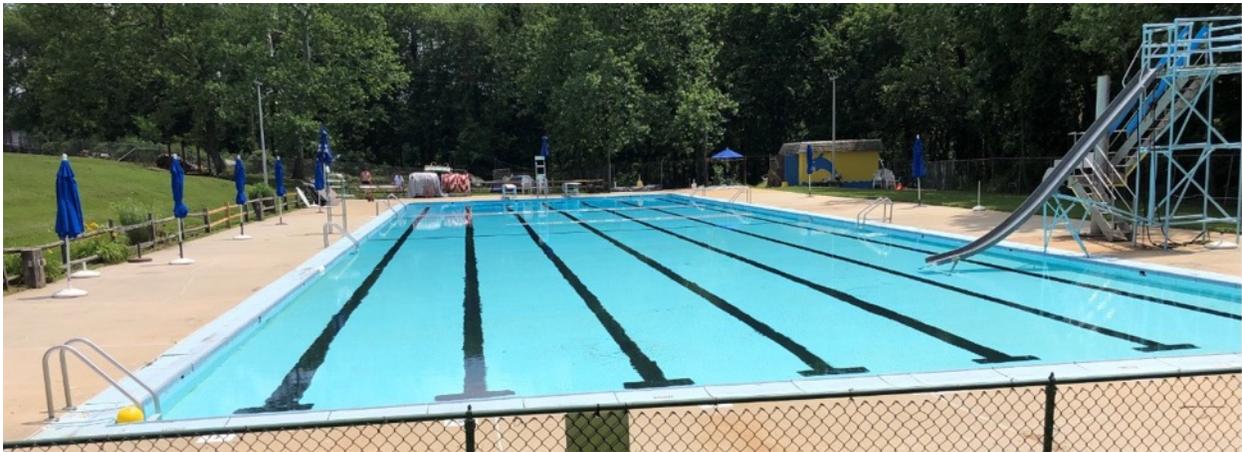
Our visual inspection of the 50 M pool prior to opening indicated the pool had the following deck equipment:

Eight (8) pool ladders in good condition

Three (3) life guard stands with umbrellas in fair condition

Anchors for backstroke stanchions (stanchions were not in place during the final site visit) – good condition

Wave quelling racing lane dividers (quantity unknown) and reels – assumed in good condition

Two (2) one meter diving stands of constructed of painted pipe, one with a fixed fulcrum and one with a broken fulcrum. Two (2) Durafirm 16' diving boards were on site and one of the boards was installed at the last site visit. The diving stands do not have access ladders or hand rails,

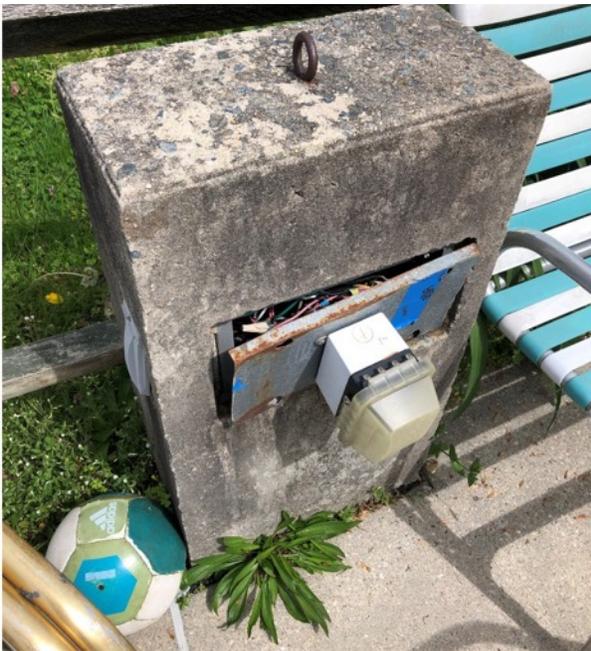
The pool is equipped with fourteen (14) underwater lights; we assume that are all working. The underwater light junction boxes appear to be enclosed in a rectangular concrete casting and are in different states of repair. It is unlikely the current junction box configuration would meet current codes.

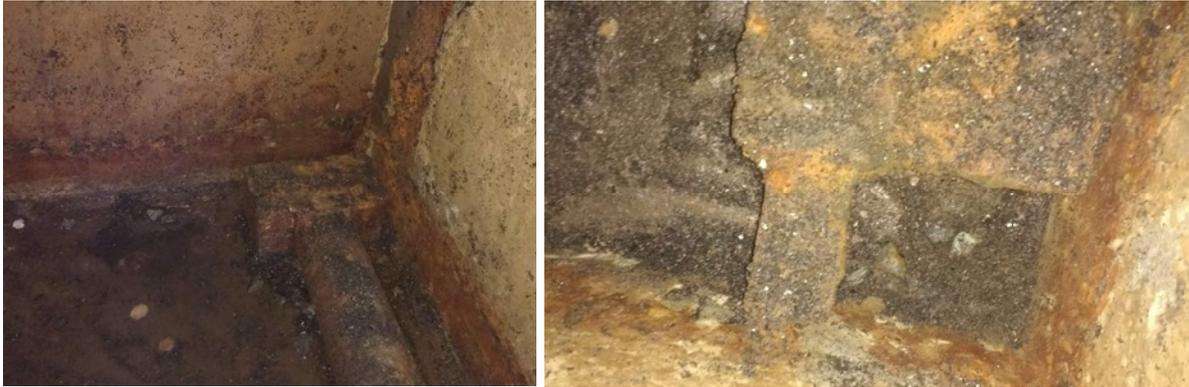
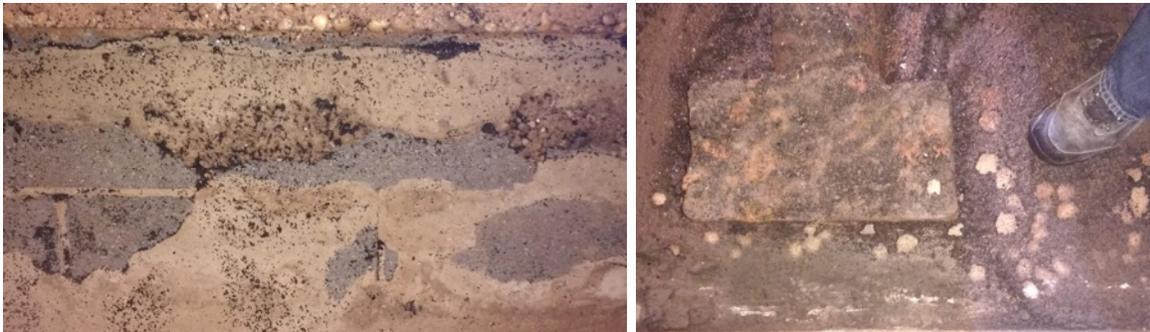
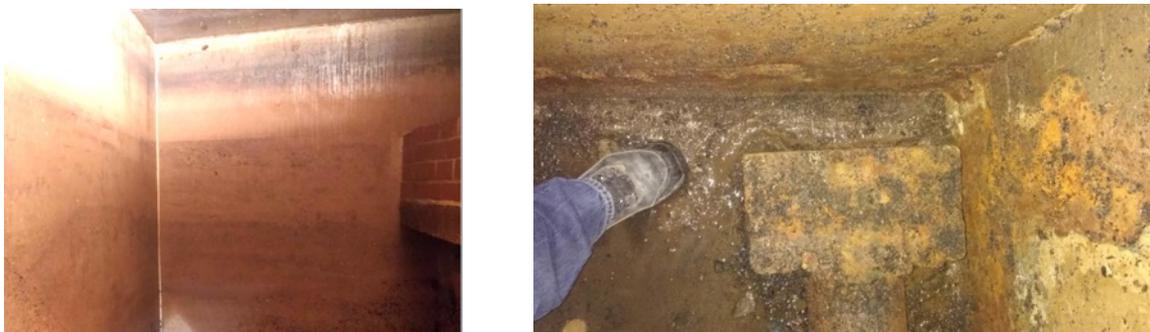
The filter media was replaced in 2019 prior to the opening of the pool. The Owner provide several photos of the work as it was progressing, some of which are shown below. The below grade filter system was field fabricated when the pool was constructed and is operating well. Unfortunately the filter is connected to the swimming pool gutter and pumping system with ferrous metal piping, which is long past its normal operational life span. This style filter can provide high quality filtration due to its large surface area and low flow rates per square foot.

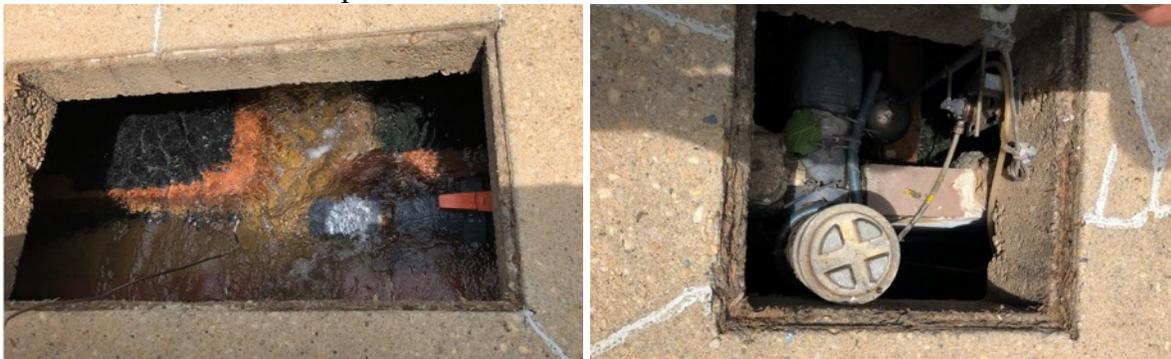
The pool filter room has an incoming 4" water line and does not have a code required back flow preventer. The fill and make-up water is introduced by a Cla-Valve float operated make-up system that adds water when the water in the filter cell/bed drops below a preset level. The system lacks the code required air gap. The mechanism is accessed thru an unsecured aluminum hatch that is located on the pool deck
